# I-25 / US 36 Bus On Shoulder Feasibility Study

# Project Background

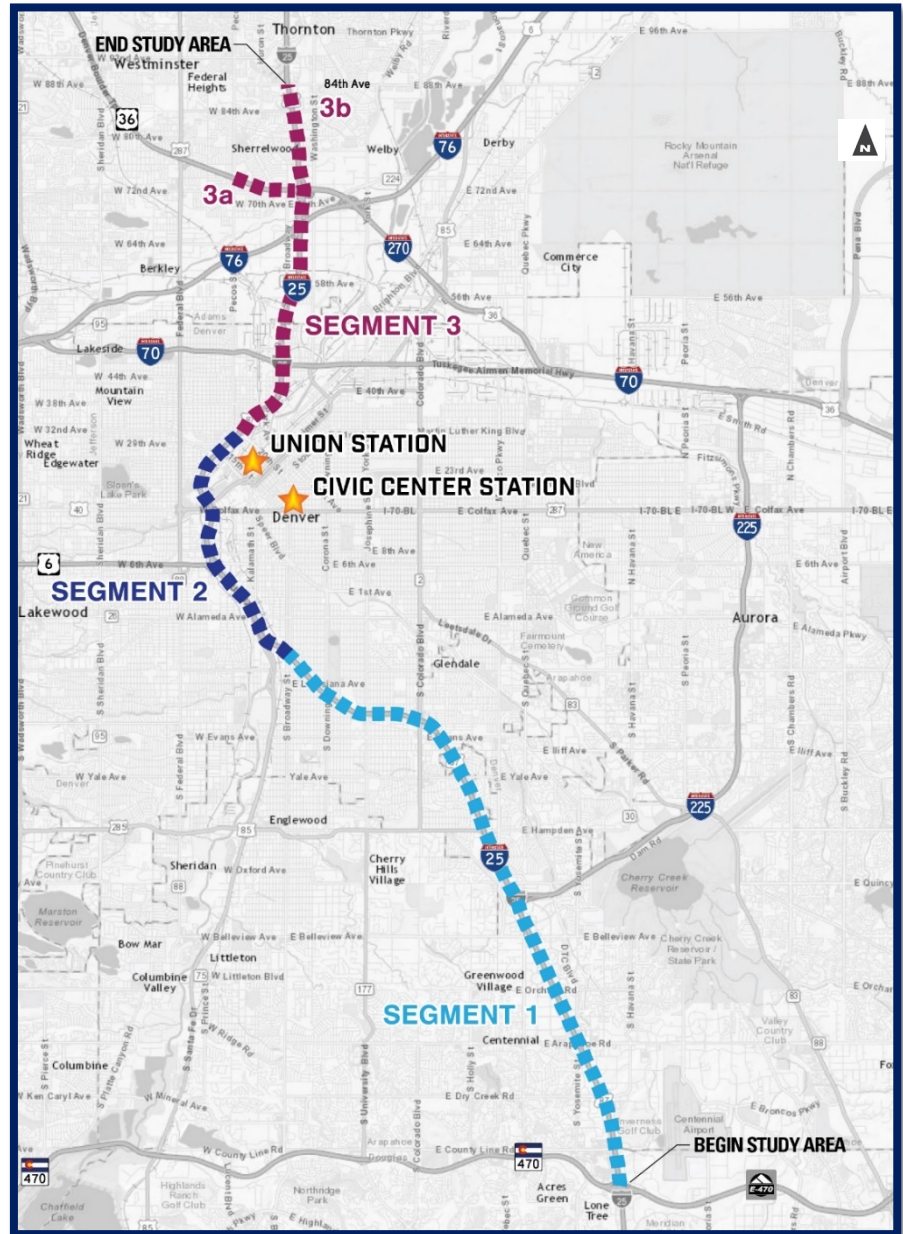
Segment 1: I-25: C-470 to Broadway  
Segment 2: I-25: Broadway to 20<sup>th</sup> St

- Lower priority segment
- Low bus volumes, buses only use a portion of Segment 2
- Future bus use is being considered as part of a separate study (Central I-25 PEL).

Segment 3:

- Seg. 3A: I-25/20<sup>th</sup> St to US 36/Pecos St
- Seg. 3B: I-25: 20<sup>th</sup> St to 84<sup>th</sup> Ave.

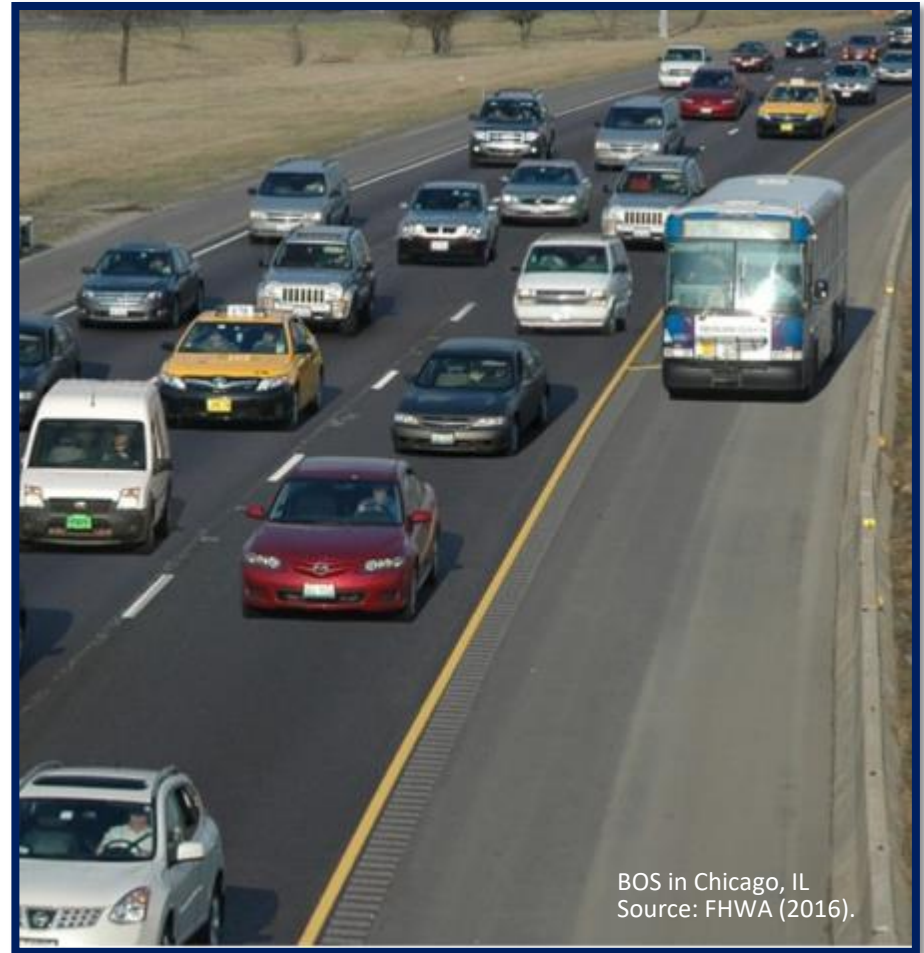
BOS in Chicago, IL  
Source: FHWA (2016).
